## **TREE SURVEY REPORT**

**Lands at Waterfall Road, Ardarostig, Bishopstown, Cork**

**Ardstone Homes**

**March 2021 / Project No. 6824**

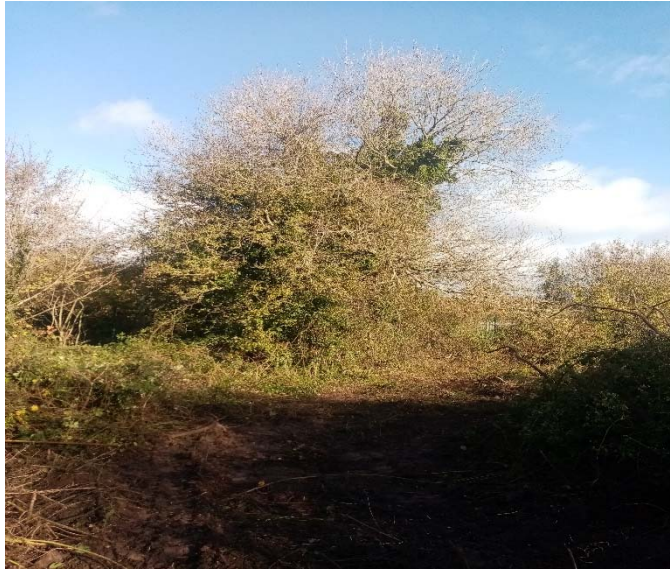
- 2.1 Six 6 category U trees are of low arboricultural value (Tag numbers 1075, 1078, 1079, 1080, 1082, 1084) are recommended for removal. (See tree report)
- 2.2 The most important tree surveyed is tree number 1086, a large Ash growing adjacent to the lower eastern corner of the proposed laneway. In addition, two 2 Ash trees 1076 and 1077 may have long term value and similarly require

protection. In addition, trees numbered 1074, 1083 and 1085 are of lesser value and may need to be removed.

**Tree number 1085 Hawthorn to foreground with 1086 Ash to rear**

- 2.3 Protection should be afforded these trees with fit for purpose barriers used in accordance with the root protection areas as per BS5937-2012. This protection is to be 1.8m high steel Heras fencing fixed in place by means of driven timber stakes during the construction period in accordance with the root protection areas mentioned in the tree schedule of this report.

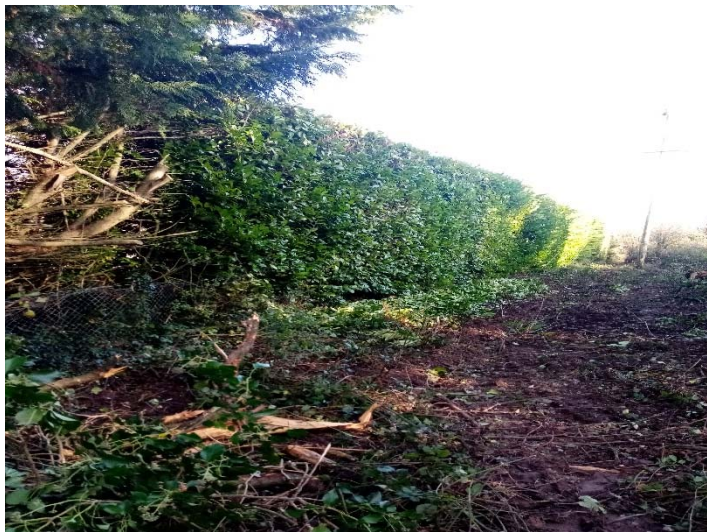
**View from west to east showing mixed Cypress and Laurel hedging to rear of existing dwelling**
