Title: **STAGE 1 QUALITY/SAFETY AUDIT**

Proposed Residential Development at Waterfall Road, Cork

Report reference: **0952R01 Rev 2**

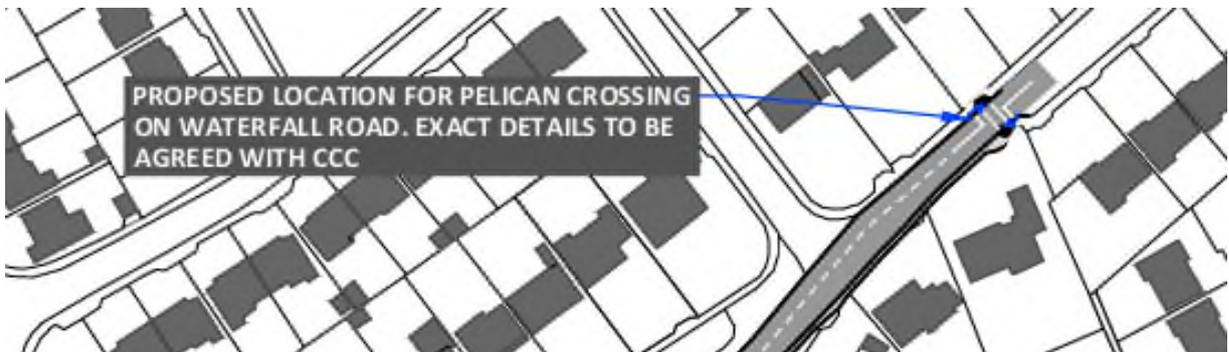
Drawing NRB-TA-001-02

It is proposed to provide a pelican crossing at the north eastern tie in of Waterfall Road. It is understood that the exact location is to be agreed with CCC. There is a risk that the location of the signals may be too close to a private access or that there may not be enough footpath space for waiting pedestrians if it is located where there is a pinch-point. This could lead to passing pedestrians entering the carriageway where they could be struck by passing vehicles.

It is recommended that the pelican crossing include buildouts into the existing relatively wide carriageway so that there is extra refuge area for pedestrians waiting to cross, there is a shorter crossing distance and that the signals also act as a traffic calming feature. Crossing specific public lighting will be required.

3.1 - Pelican Crossing	Yes	Yes	<i>NRB Comment</i> – the location & outline design was agreed in Principle with Cork County Council (CCC).	Yes
3.2 – Raised Platform At Audi	Yes	Yes	<i>NRB Comment</i> – A ramp warning sign has been incorporated and the crossing is to be as far back as possible (to match the existing crossing).	Yes

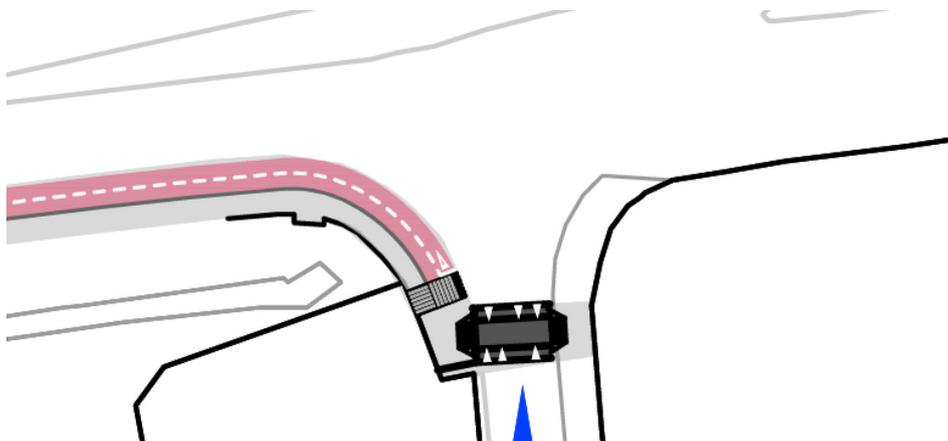
Drawing NRB-TA-001-02

It is proposed to provide a raised uncontrolled crossing at the entrance to the Audi Garage/Heiton Buckley. There is an existing uncontrolled crossing at a similar location. There is a risk that if the crossing is brought closer to the junction with the N40 ramp that vehicles turning at relatively high speed may not be able to stop before the crossing point.

It is recommended that the crossing be suitably set back from the junction mouth.

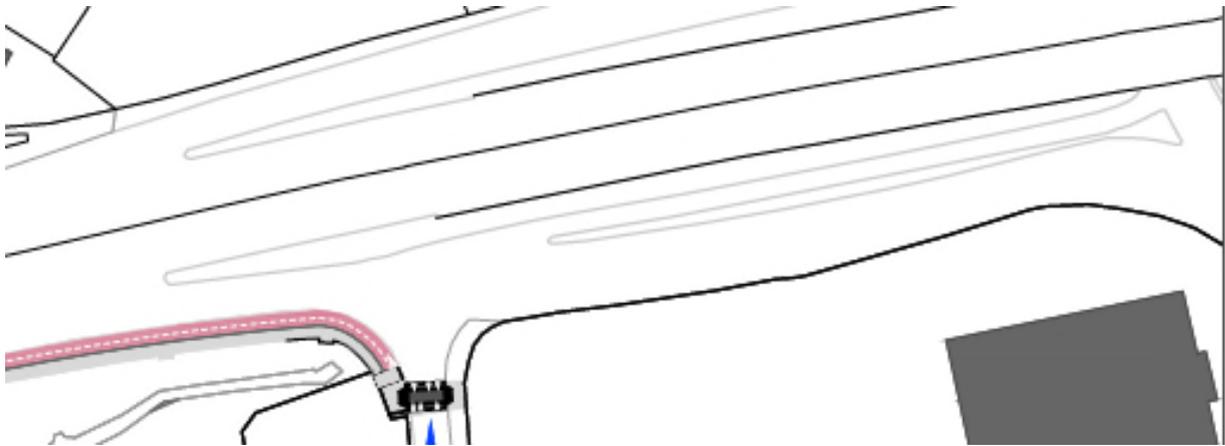
Drawing NRB-TA-001-02

The existing cycle track along the N40 ramp from the N71 roundabout is only one-way and is also available to pedestrians. This could lead to conflict between cyclists that will be travelling contra flow when the new facility is opened.

It is recommended that the existing one way cycle track be made a shared use facility in both directions from the access to the Audi Garage/Heiton Buckley to the Dunnes Stores pedestrian crossing on the N71.

3.3 – Existing Cycle Facility on the N40 Ramp	Yes	Yes	<i>NRB Comment</i> – the existing concrete apron area to the southern boundary of the ‘ramp’ (identified in the RS Audit Report) is a shared surface, used by cyclists and pedestrians, and has operated as same for many years without any issues arising we understand. It is currently very infrequently used. There is an historic push button controlled crossing provided immediately at the Audi Garage, which, when in operation, previously allowed the safe crossing of dismounted cyclists. Notwithstanding the crossing status, at some point, eastbound cyclists must currently eventually dismount to cross at the busy N40 Bandon Road roundabout.	Yes

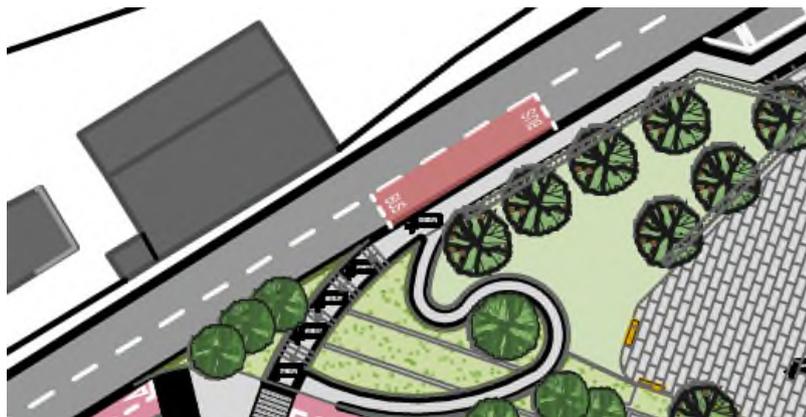
Drawing NRB-TA-001-01

There is a proposed on-road bus stop for westbound buses on Waterfall road along the development. There is no corresponding stop for eastbound buses. This may lead to buses stopping where there is no safe place for passengers to wait which may increase the risk of them being struck by passing traffic.

It is recommended that an eastbound bus stop with hardstanding/kassel kerb etc. be provided with a suitable pedestrian crossing to the proposed development.

3.4 – Eastbound Buses	Yes	Yes	<i>NRB Comment</i> – the illustrated westbound bus stop is shown to illustrate how a bus stop is facilitated and can be provided in the future. In a similar way a bus stop can be provided in future for eastbound buses on the opposite side of the road.	Yes
